PROFESSIONAL HOME INSPECTION REPORT

Concerning: property address
(Address or Other Identification of Inspected Property)

By: RAUL CARRILLO MONTANO 20404 5/19/2020
(Name and License Number of Inspector) (Date)

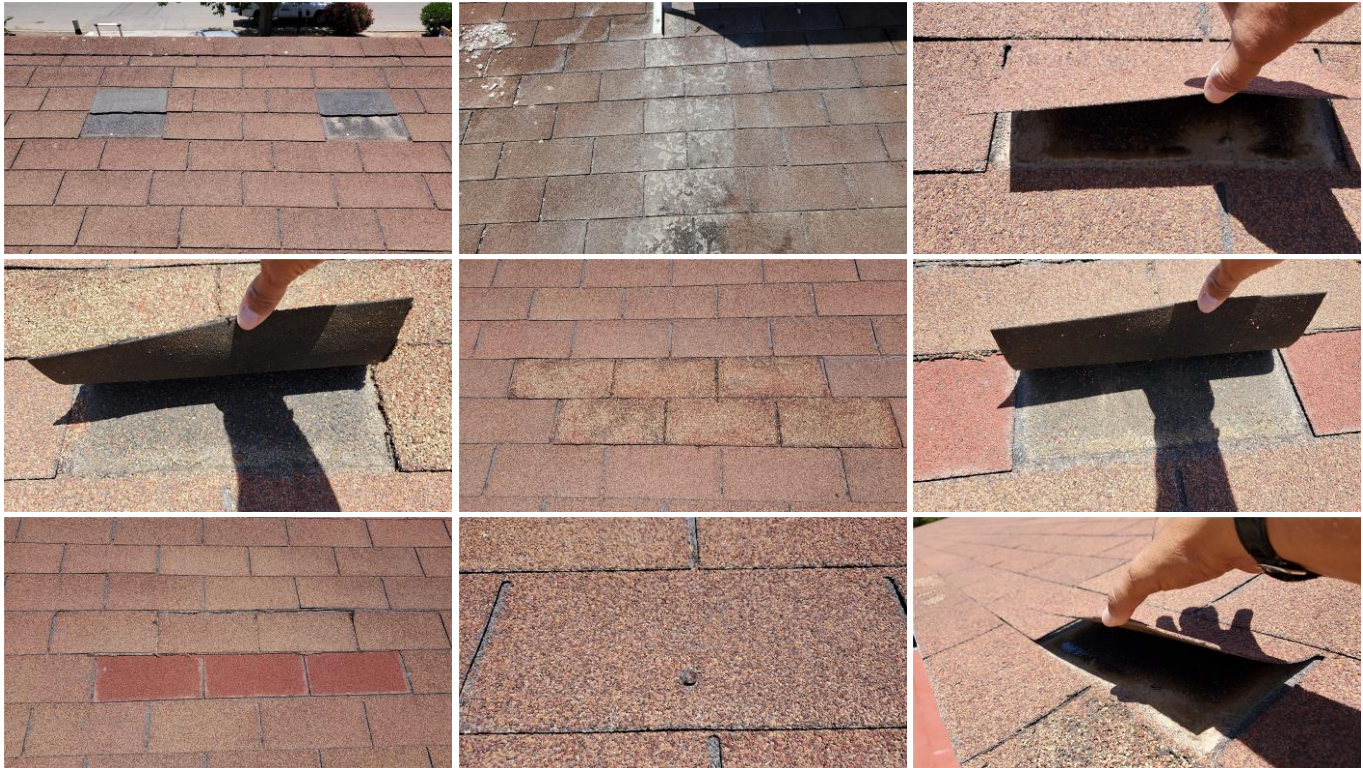
1. There were several shingles broken, missing, detached, and / or lifted due to lower wind resistance. Shingles may become detached and blow completely off from the roof. This type of failure is often caused by poor bonding of the adhesive strips, resulting in tab-uplift forces that break the bonds completely. The wind can then lift the tab and enter beneath the affected shingle, increasing the uplift forces on that entire shingle.

2. There were some nails exposed that should be removed or sealed to avoid water penetration. Exposed nails will corrode over time, and expansion and contraction may eventually expand the nail holes enough to allow leakage. Shingle manufacturers recommend replacing any shingles with exposed fasteners. They consider caulking nail heads to be a temporary repair.

3. **Evidence of replaced shingles.** - A patch is not always a problem, but it usually indicates a previous leak or damage. Patches warrant a close look to determine there is a proper tie in with surrounding shingles. If surrounding shingles are old and brittle, a good tie in is hard to accomplish.

4. The shingles below the cooling equipment appeared to be noticeably worn. Water draining or leaking from a rooftop mounted evaporative cooler can cause hard water calcium stains on asphalt shingle roofs. Sometimes they can be only white stains on the surface, which do not cause any damage to the shingles. But other times these calcium stains can hide some shingles damages.

- **CORRECTION NEEDED AND FURTHER EVALUATION RECOMMENDED:** Contact a qualified roofing contractor for further evaluation and repair / replacement as needed.

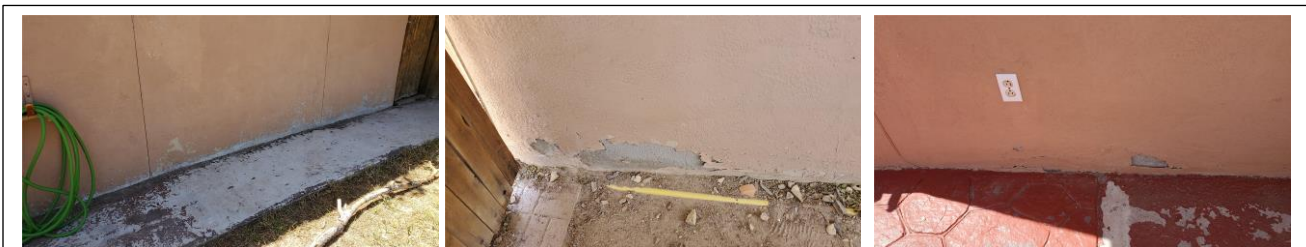
- Wall Conditions:
 - ☐ Brick Veneer - ☐ Wood - ☐ Metal - ☐ Stone - ☐ Vinyl - ☒ Stucco - ☐ Fiber-Cement - ☐ EIFS - ☐ Other
- 1. Several locations with paint and plaster deterioration.
 Recommend all failed caulking or voids in caulking at junctions of dissimilar materials including but not limited to door and window frames, thresholds, plumbing penetrations, siding, trim and light fixtures be improved in order to prevent possible moisture penetration in several locations. These are also annual maintenance and cosmetic issues to check regularly.

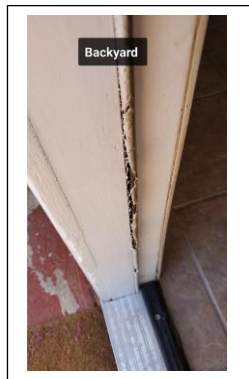
- Backyard egress door with the weather strip deteriorated.

Recommend correction to ALL defective interior & exterior doors as to allow proper safety and function.

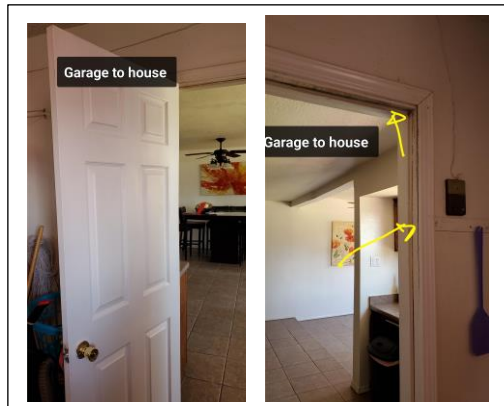
- Should be fire rated. The door may be a solid-core wood not less than 1-3/8" (35 mm) in thickness, solid or honeycomb core steel doors not less than 1-3/8" (35 mm) thick, or 20-minute fire-rated doors.
- Weather strip deteriorated in garage access door: The door between the garage and the interior of the house should be well sealed to prevent automobile fumes from entering the house.

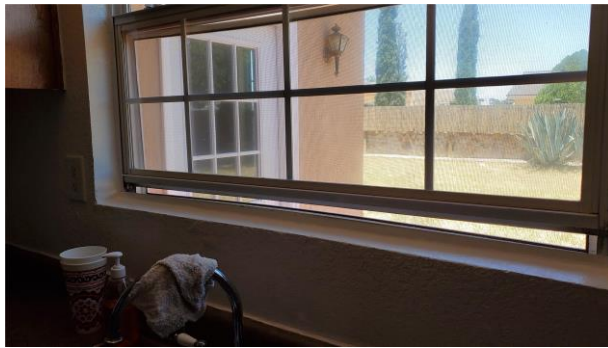
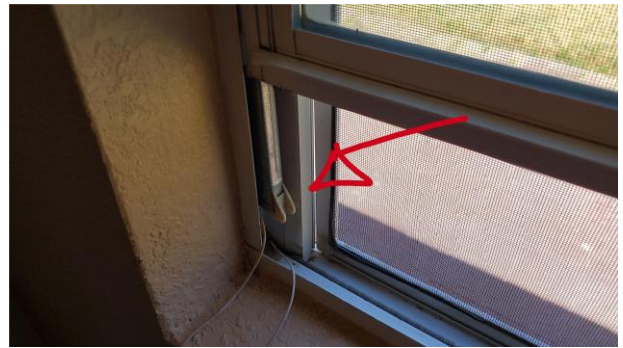
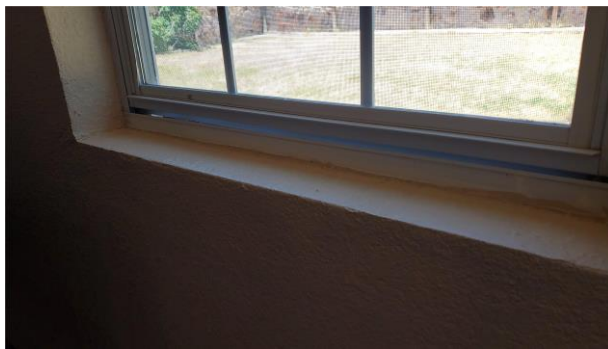
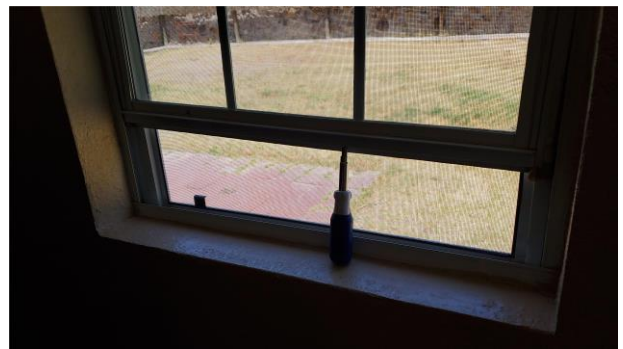
1. Several windows were not operating as needed,
 - a) The spring enclosure was exposed.
 - b) Some windows did not stay open or open/close mechanism was deficient.
- **Recommend correction to ALL defective windows as to allow proper safety and function.** All windows must be able to open for safety concerns, there are many reasons why there should be at least one opening window in each room typically used for living (bedrooms, living room, kitchen); an openable window could save one's life as it offers an easy way out in the unfortunate event of an emergency.

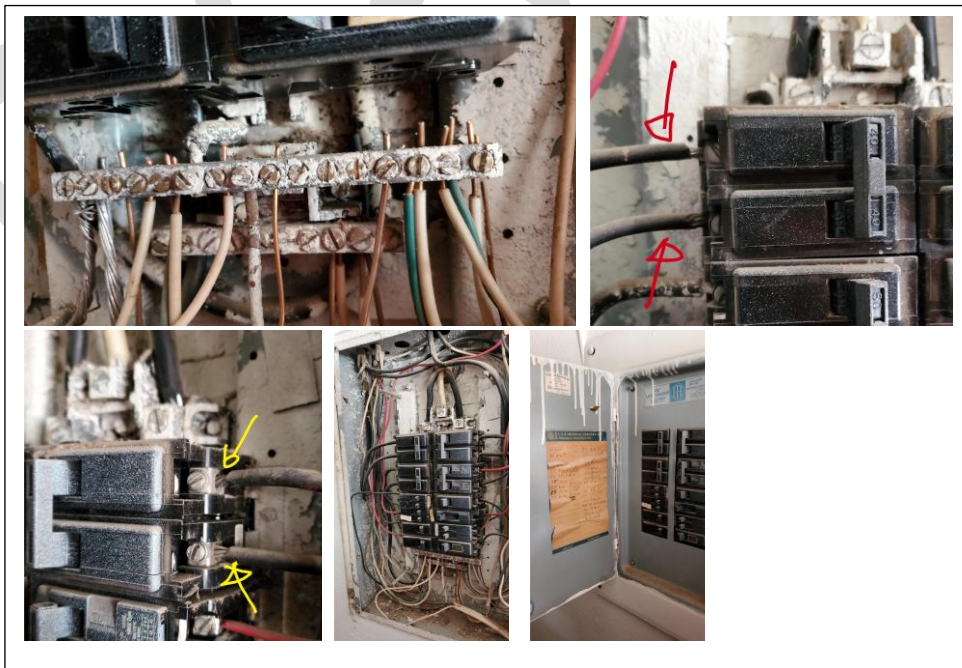
1. The electrical panel lacks main circuit breakers. This panel needs more than 6 movements to turn off the power of all the house and this is a deficient. This is a safety hazard because the NEC requires no more than 6 switches and must be close enough together for all to be operated with no more than 6 hand movements.

2. Double tapped neutral wires were observed in the service panel. One neutral wire per screw set is the recommended installation requirement.
3. The service panel is NOT completely and/or properly labeled. All breakers must be specifically identified as to appliances, lighting and receptacles. *Checking each breaker to see if each one was identified correctly is beyond the scope of the inspection, this evaluation should be conducted by a professional electrician.*

4. The aluminum wire connections did not show anti-oxidant compound. Without it, aluminum wiring will oxidize, and aluminum oxide is a good insulator. Therefore, oxidation will cause a poor connection and become overheated, perhaps enough to cause a fire.

Correction needed and further evaluation by professional electrician.

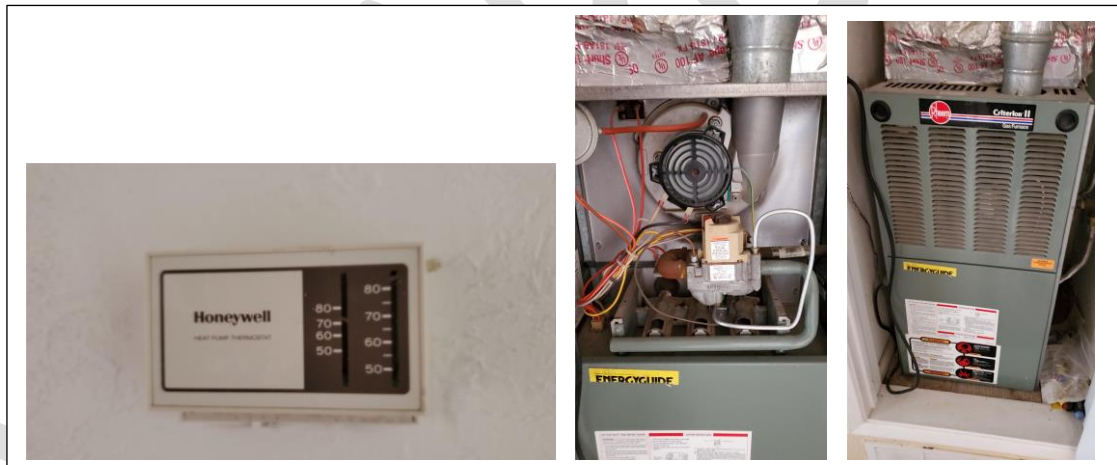
Furnace not reaching set temperature

Recommend correction and reinspection prior to close of escrow or evaluation by a licensed HVAC contractor.

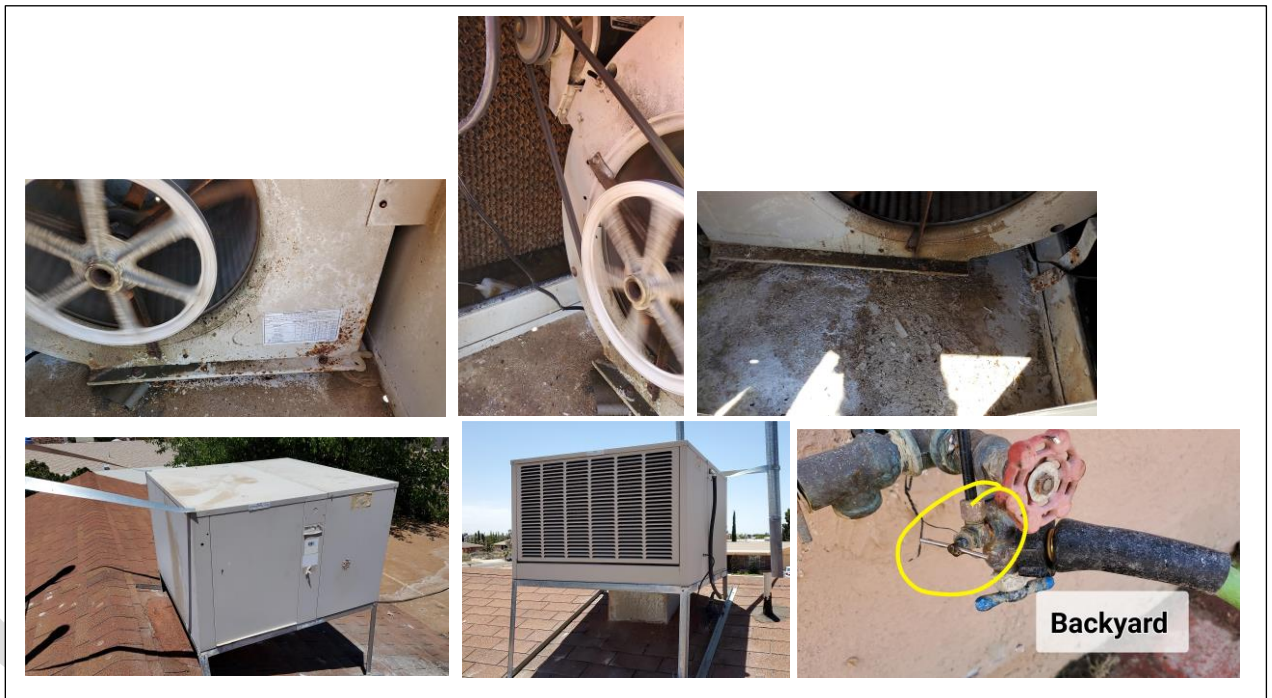
1. The enclosure needs to be cleaned.
2. The water shutoff valve was leaking.
3. Rust or corrosion spots were noted on the enclosure.

The corrosion of steel enclosures results from exposure to oxygen and moisture. Corrosion is accelerated in the presence of salt from roadway deicing, salt water or perhaps salts deposited from other sources. There are methods for preventing corrosion of structural steel. Refer proper maintenance with a qualified technician in HVAC in a short time, the corrosion can cause water leaks.

Corrections needed in order to prevent further damage, proper maintenance and regular inspection is necessary.

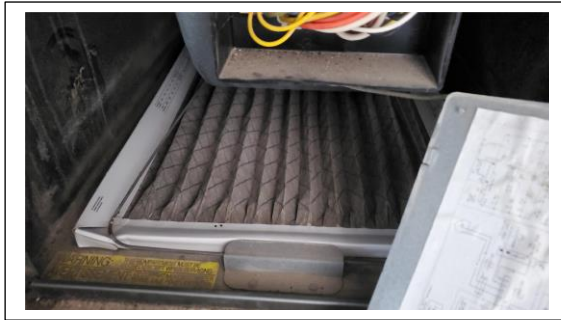
1. The air filter was dirty.
Corrections needed.

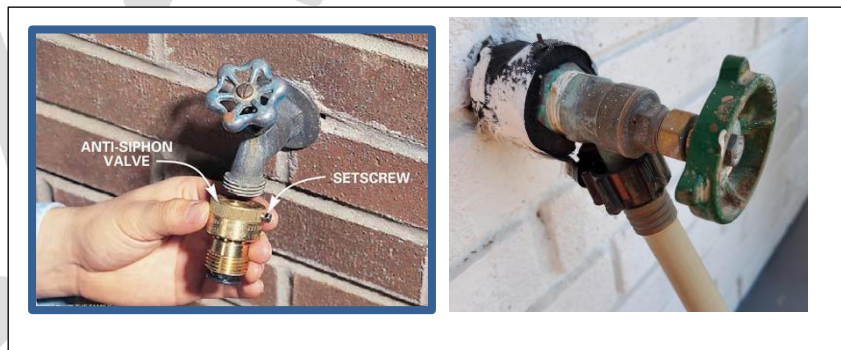
1. One or more of the exterior water hose bibbs {faucets} was not equipped with a back flow and/or anti-siphon {vacuum breaker} device. An anti-siphon device prevents unsanitary water from being pulled back through a garden hose and/or lawn sprinklers and contaminating the household water system.

Corrections needed.

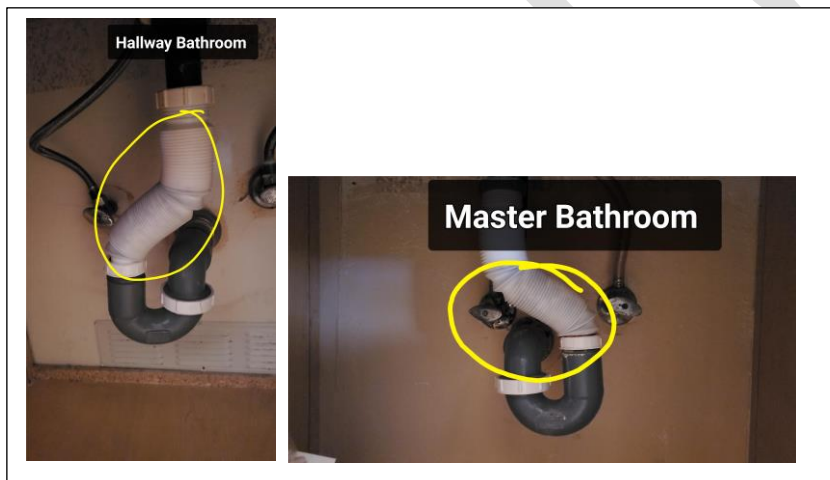
1. Bathrooms sinks with a corrugated piece of pipe that is no approved. Between the fixture and the trap is the tailpiece. This pipe should be smooth-walled material that is compatible with the trap material. The flexible, ribbed material available at big-box retailers isn't allowed because the ribs hold unsanitary materials, and this material is prone to clogging. The vertical distance between the fixture and the trap should be less than 24 inches. This helps prevent stuff from building enough force to blow out the trap's water seal. "2009 IRC P3002.1 Piping within buildings. Drain, waste and vent (DWV) piping in buildings shall be as shown in Tables P3002.1(1) and P3002.1(2) except that galvanized wrought iron or galvanized steel pipe shall not be used underground and shall be maintained not less than 6 inches (152 mm) above ground. Allowance shall be made for the thermal expansion and contraction of plastic piping."

- **Correction needed.**

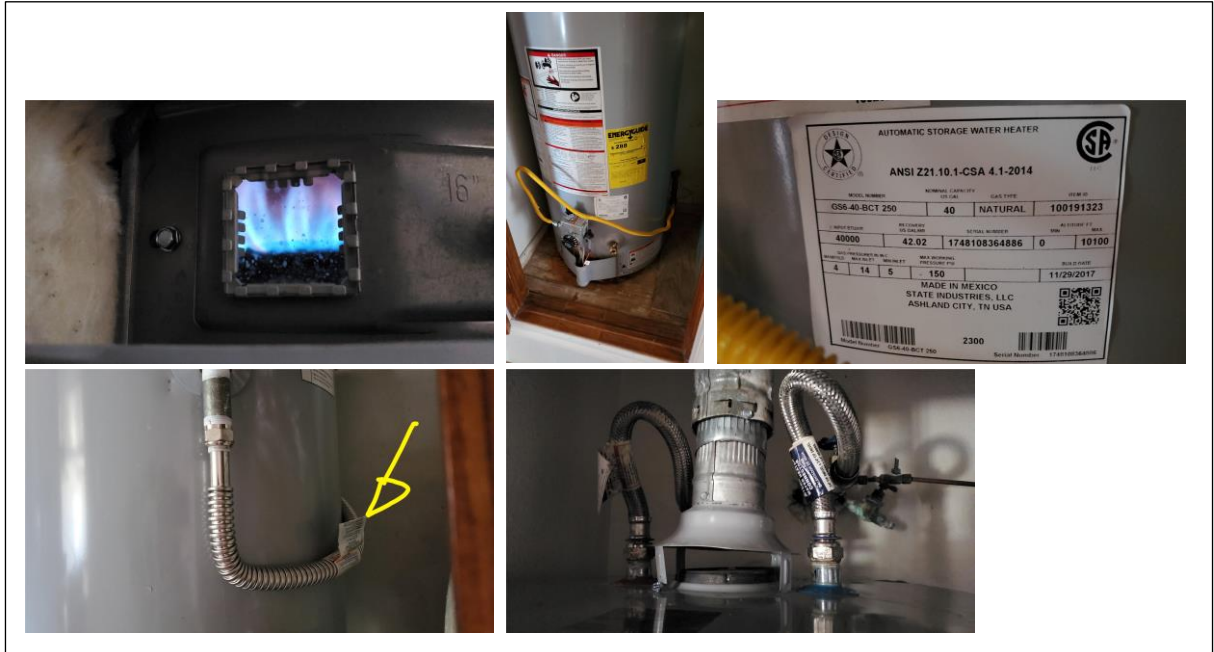
3. A drainpipe was missing. The pan drain should be terminated in indirect waste or outdoor 6-24" above grade. Recommend its installation.
4. There was not sediment trap on water heater gas pipe. Sediment traps are intentionally installed to help prevent sediment in the gas piping from getting into the gas valve or burner area of an appliance and fouling things up.

Corrections needed.

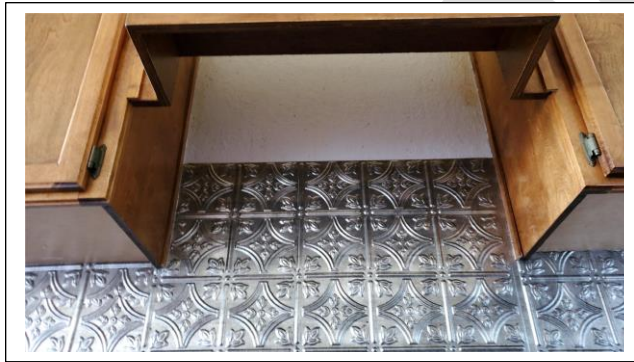
- There was no range hood. Most residential building codes do not require a range hood above a stove or cooktop, but it is important to ensure its locale is not the exception. The range hoods are designed to collect airborne grease, toxins, moisture, and cooking odors. **Deficient.**

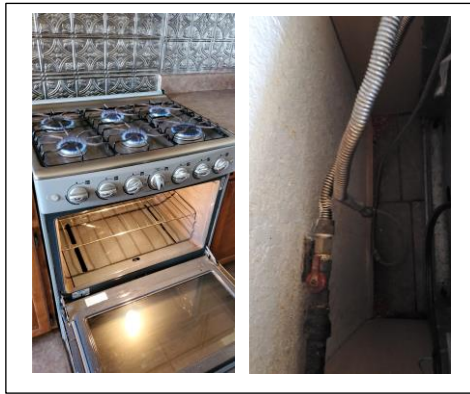
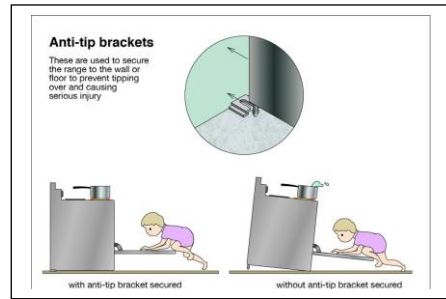
- Stove and oven operated normally.
- Anti-tip bracket is missing from range installation (to anchors it safely to the floor or the wall). All free-standing, slide-in ranges include an anti-tip device and is essential in the safe operation of the range. It provides protection when excess force or weight is applied to an open oven door. Anti-Tip devices became a UL (Underwriters Laboratories) safety standard requirement in 1991. This is a safety issue as the oven could potentially tip over if a child were to stand on the door.
- Correction needed.**

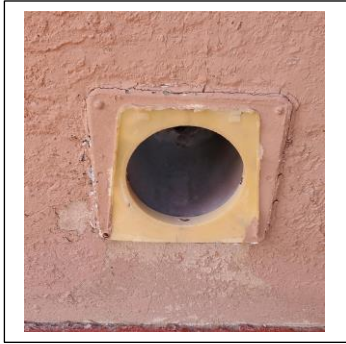
1. There was no dryer exhaust hook. The duct termination should be fitted with a closeable gravity or automatic damper (a backdraft damper).

- Correction needed.
