PROFESSIONAL HOME INSPECTION REPORT

Concerning: property address
(Address or Other Identification of Inspected Property)

By: RAUL CARRILLO MONTANO 20404 5/19/2020
(Name and License Number of Inspector) (Date)

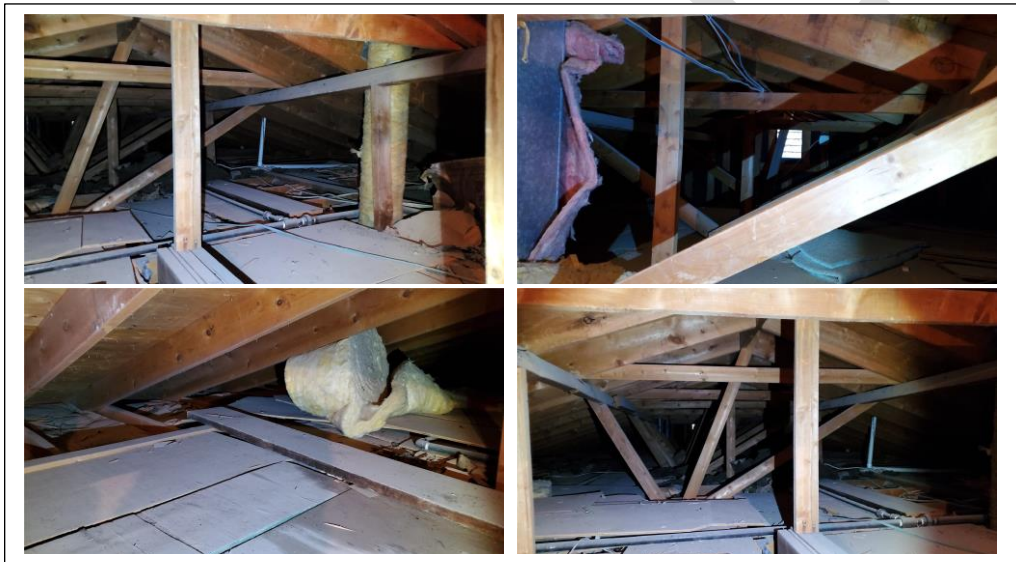
- In my opinion, the **roofing structure** was found to be in good condition on the Date and Time of the Inspection. Therefore, the opinions expressed are one's of apparent conditions and not absolute fact and are only good for the date and time of the inspection.
